CHEMICAL ACCIDENT PREVENTION & PREPAREDNESS

Corrosion-related accidents in petroleum oil refineries

This is the fourth issue of the JRC-MAHB Lessons Learned Bulletin for chemical accident prevention and preparedness.

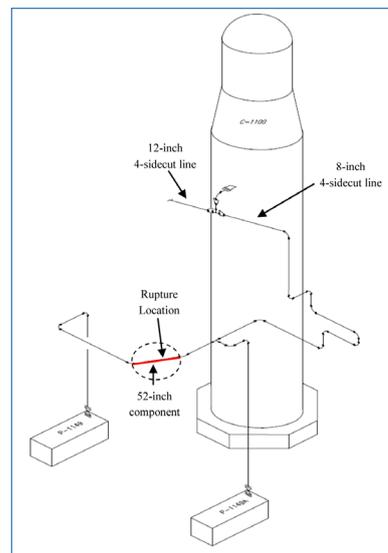
- Subsequent testing determined that the rupture was due to pipe wall thinning caused by sulphidation corrosion. In fact, over a period of nearly 35 years, the 52 - inch piping component had lost on average, 90 percent of its original wall thickness in the area near the rupture.

- The 4-sidecut piping circuit containing the 52-inch component that failed was constructed in the mid-70's of ASTM A53B carbon steel which had no minimum specification for silicon content. Silicon in carbon steel inhibits sulphidation when the silicone concentration is above 0.10-wt%. Inspection frequencies were established based on data associated with pipes of a different material composition with higher resistance to corrosion. The crude distillation unit of the pipe in question was a result of sulphidation corrosion that was apparently overlooked for a long period of time.
