CHEMICAL ACCIDENT PREVENTION & PREPAREDNESS

Major accidents involving explosives

Number 8
December 2015

JRC99808

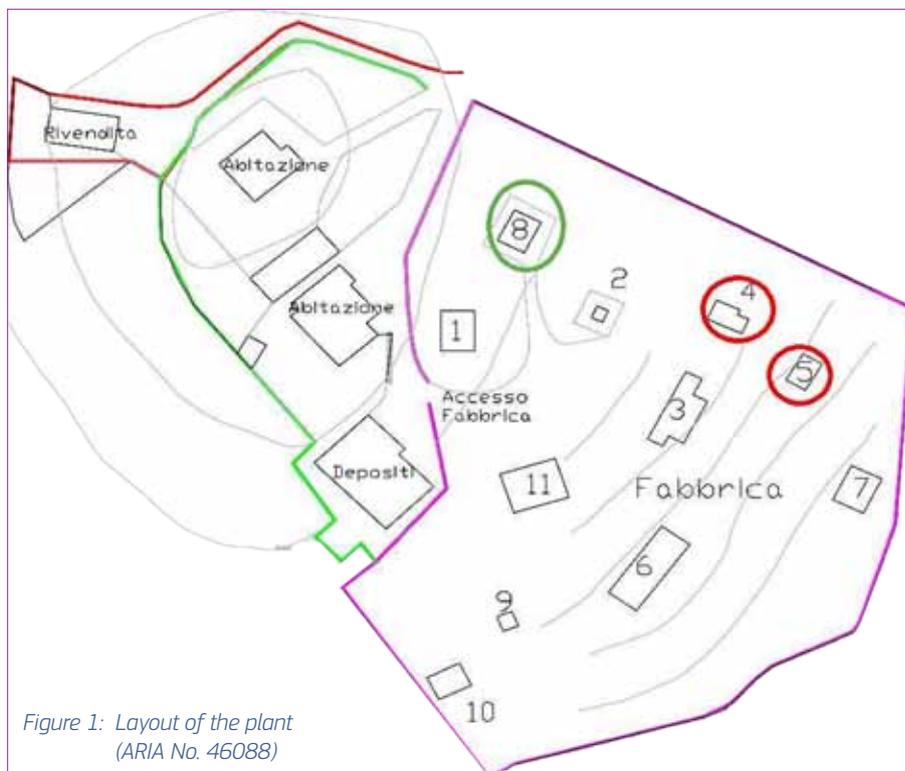
Figure 1: Layout of the plant (ARIA No. 46088)

A series of explosions occurred in the finished products storage area of a fireworks factory. The initial three explosions in short succession presumably occurred in the vicinity of sheds No 4 and 5 (Figure 1), which were used to store finished products (fireworks). Forty minutes after the first three detonations a fourth explosion occurred in explosives storage building No 8. At the time of the first series of explosions three workers, the operator and two technicians were transferring fireworks from the shed No

4 to shed No 5, using a small truck that was available for internal transfer. All of them died immediately in the first set of explosions. The fourth victim, the operator's son was killed in the fourth explosion while he was looking for his missing father.

A fire fighter was also hit by a projection triggered by the explosion of building No 8 and died in the hospital three months later. The successive explosions destroyed the factory and the blast waves caused serious damages in the buildings within a 500 m radius. The damage caused as a result was estimated to be more than 1.5 million Euros.

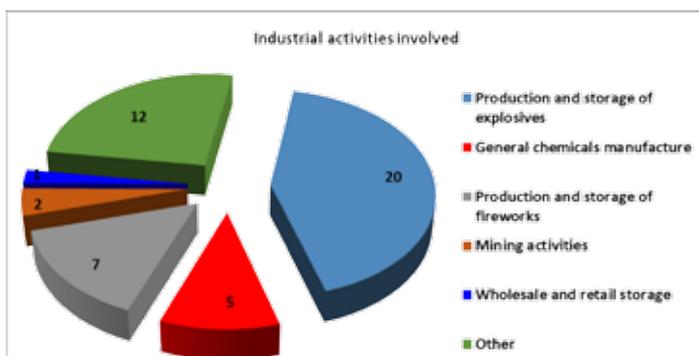
Figure 4: Number of major accidents involving explosives (Source: eMARS)

Accidents involving explosives are still occurring with a regular tendency, with two to four events a year almost every year since 2000. In the last five years alone, there were twenty major accidents in Europe involving explosive substances¹. Many of the events studied also appear to be repeat accidents, that is, the same accident occurred more than once within the same facility over a number of years (e.g., EMARS Accidents #729 and #1031; EMARS Accidents #276 and #918; ARIA No. 32086 and No. 45545). This recurrence is a strong indication that many sites are still failing to learn from past accidents.

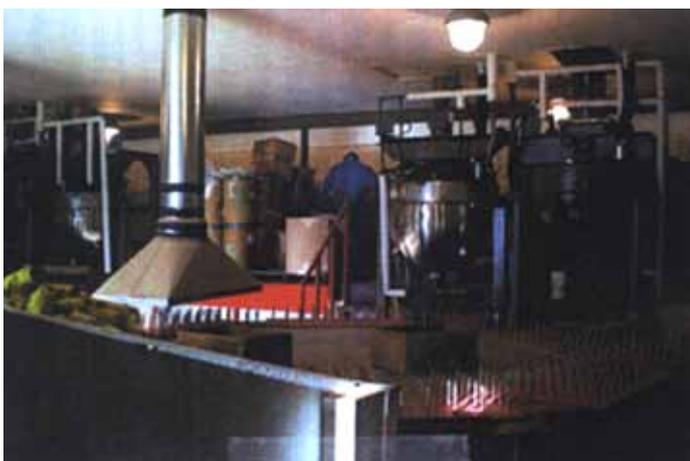
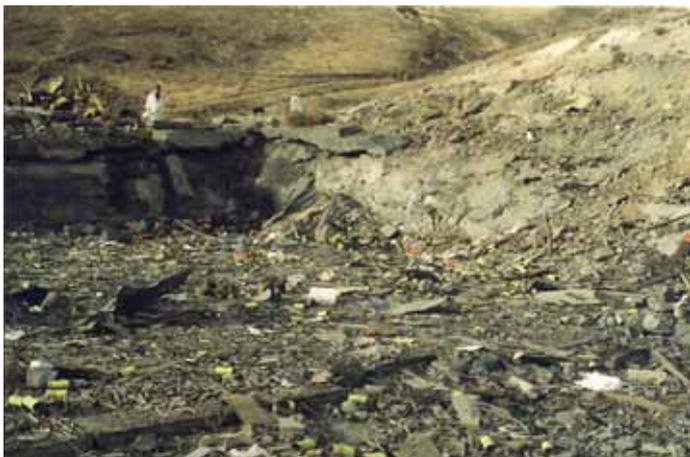
Figures 2 and 3: Booster Room 2 before and after the explosion (CSB)

Two massive explosions just seconds apart destroyed the Sierra Chemical Company's Kean Canyon explosives manufacturing plant in Nevada, killing four workers and injuring six others. Because everyone was killed, the exact cause of the accident could not be determined. However, it is thought that on the day before the incident, leftover base material was left in the mixing pot by an operator but this information was apparently not communicated to the next shift. The next morning the worker returned, and may have assumed that the pot had been emptied. Without checking its contents, the worker turned on the motor to the agitator blades, setting off the initial explosion. This explosion occurred in a room where workers made "boosters" - small explosive devices used in the mining industry to detonate larger explosives. A second, more powerful blast destroyed a building used for drying explosives, leaving a 40-by-60-foot (12 m x 18 m) crater that was up to six feet (1.8 m) deep. The explosions had the force of a magnitude 2.0 earthquake and were felt some 20 miles (32 km) away from the plant. Sierra Chemical estimated that in all, 47,000 pounds (21 t) of explosives were consumed during the accident. The facility was never rebuilt.

It is speculated that explosive material remained in a pot over night and due to the low outside temperature it solidified. The bottom of the mixer blade, which was embedded in the solidified explosives in the pot, detonated the explosives by impact, shearing, or friction of the explosive material with the pot wall. Another possibility is that chunks of explosive material were pinched between the mixer blade and the pot wall, causing the detonation.

- The storage facilities and the two workshops were closer to each other than it is determined in the related guidelines, allowing propagation of explosion to occur. Also, it was found that building constructions were not compatible with the recommendations by the Department of Defense guidelines.

- It is particularly important that high risk sites also employ appropriate technical measures to counter safety management system weaknesses. Appropriate separation distances between buildings are a standard technical measure to mitigate explosive risk. Having a protective building structure in place that complies with regulations could also prevent further injuries in case of an accident.
