Lessons Learned Bulletin No. 5

CHEMICAL ACCIDENT PREVENTION & PREPAREDNESS

Major accidents involving fertilizers

Number 5
June 2014
JRC91057

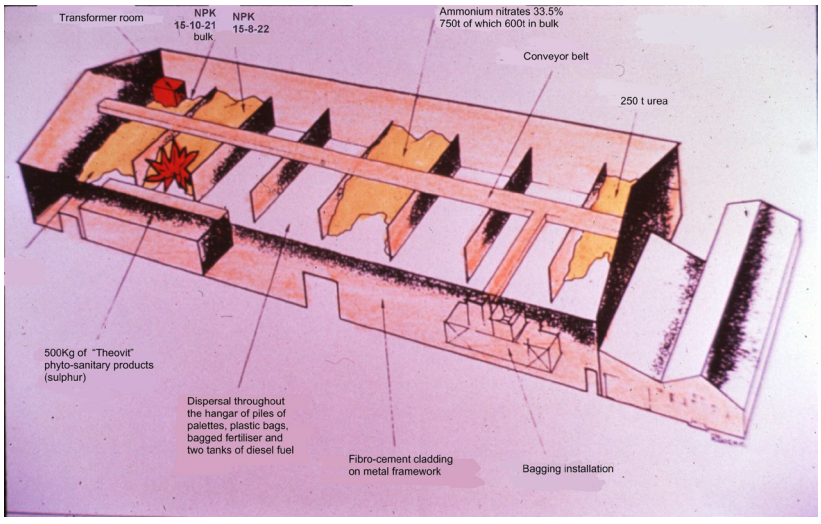
A fire occurred in a warehouse storing fertilizers and chemical products belonging to a wholesale distributor of numerous products, including sugar, molasses, fertilizers, and cereals. The storage installation was subdivided into 8 compartments of which two contained NPK (15% N, 8% P, 22% K) fertilizers in quantities of 600 tonnes and 850 tonnes respectively. In addition, one compartment also contained 650 tonnes of ammonium nitrate fertilizer and the other was also storing 200 tonnes of 46% urea solution. On 29th October 1987 smoke was detected by an operator in Box No. 2 of the warehouse, that is, the compartment that contained 850 tonnes of NPK fertilizer. The first reaction of the personnel was to attack the source of the fire with portable fire extinguishers, in the absence of activated fire hose reels. Arriving on the site, firemen observed that very thick smoke was emitted from the storage compartment. It also appeared that a fire was burning beneath the mass. However, the intervention of the firefighters appeared to focus solely on the presence of ammonium nitrate fertilizer, ignoring, the nature of the other chemical products. Further, disagreements between experts occurred which delayed the application of effective response methods. The accident resulted in the slight injury of three employees and 38000 people were evacuated for 8 hours.

Figure 1: The installation concerned Source: ARIA N° 5009

- The incident would certainly not have reached such proportions if efficient means for response had been applied as soon as the heating had been detected, preventing the rapid development of the fire.

- Appropriate extinction equipment for the products stored must be at the disposal of personnel trained in emergency response, the prevention of risks, and the detection of abnormalities. In this case, the personnel of the establishment were not aware of the risk associated with fertilizers and only had powder extinguishers which are ill-adapted to this type of fire. No water extinguishing equipment, such as, fire hose reels, were available on the site.

- A sound characterisation of the risks involved, particularly an understanding the implications of storing of dangerous substances is indispensable to the implementation of efficient fire prevention and firefighting plans. Doubtless the loss of information concerning the nature of the products involved in the fire played a major role in the development of the incident. In the absence of characterisation of the products present and thus of the risks involved, disagreements between experts occurred which delayed the application of effective response methods. Furthermore, the establishment was not classified by the fire department and was subject to no emergency plan. It is essential that each emergency centre should hold an inventory of potential risks for its sector of intervention to enable efficient response from the moment that the alarm is given.

- Effective response requires also that there should be adequate and permanently available sources of water including, for example, when the tide is going out.
