Lessons Learned Bulletin No. 6

Chemical Accident Prevention & Preparedness

Natech Accidents

Number 6
December 2014
JRC93386

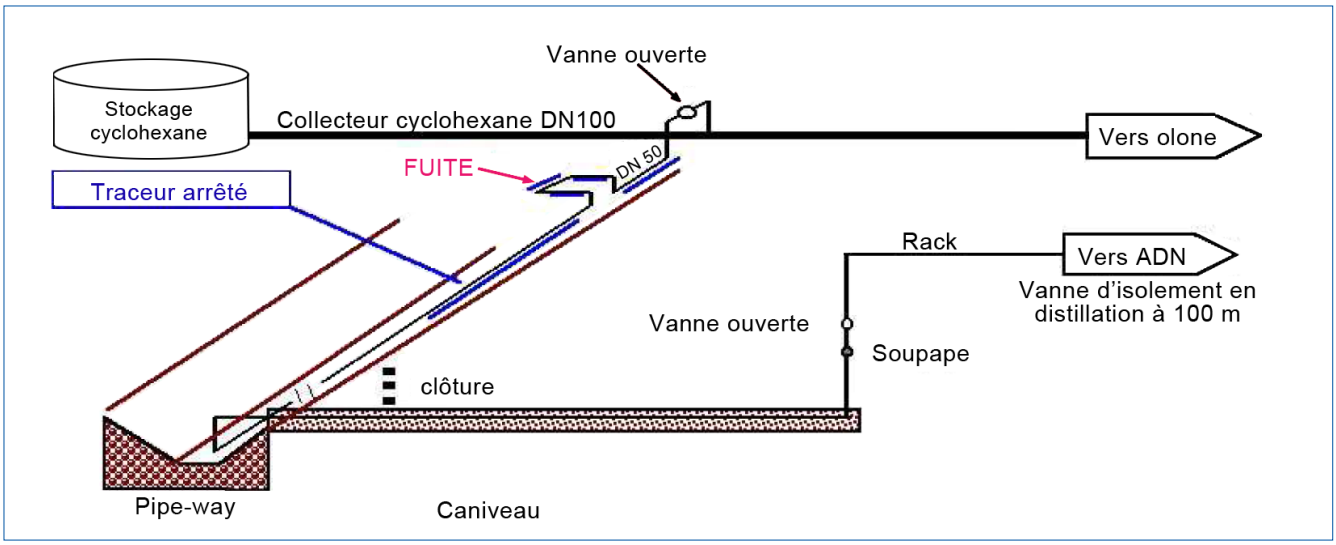
The temperature varied greatly over the weekend of mid-December. Lacking a functional temperature control, the varying temperature in the pipe caused the cyclohexane to expand and contract. A malfunction of the pipe heating device (T < 6.5°C) led to the formation of the blockages in the pipe canal. Ultimately, the DN 50 mm branch pipe ruptured at the expansion loop, creating a hole about the size of the palm of one's hand. The expansion loop was the part most exposed to the changes in temperature because of its shape and position up above the pipe-way, (the trench holding the pipework)(see Figure 3).

- In early December 2002, freezing temperatures caused the cyclohexane to solidify in the manifold. The large variation in the temperature caused an expansion/contraction of the cyclohexane which contributed to the rupture of the pipe.
- The DN50 mm manifold was permanently open even in the event of non-use and only the adiponitrile (ADN) production unit admission valve was closed.
- The location of the released cyclohexane was found by its odour, indicating that no monitoring technology had been implemented on the pipe.

Figure 3: The affected process (Source: ARIA No. 23839)

- Operators must be aware of the physical characteristics of the dangerous substances, on site such as their tendency to solidify in extreme cold temperature. These factors should be included in the HAZOP or other hazard identification studies for the affected chemical process (See also Chemie Pack accident at http://www.onderzoeksraad.nl/uploads/items-docs/1805/Rapport_Chemie-Pack_EN_def.pdf). Also, where significant variations of outsid e tem p era t u re can be expected, operators should identify possible hazards that might be triggered.
- The cyclohexane spilled was revealed by its odour. Relying on odour alone for detection is not a recommended practice on sites where large volumes of dangerous substances are stored. Proper detection in case of release of dangerous substance is crucial to enable staff to act immediately in case of an emergency.
